WEEKLY OVERSIGHT REPORT

CH2MHILL**Weekly Summary Report
USEPA Oversight, Sauget Area 1, Sauget, IL
WA No. 239-RSBD-054V / Contract No. 68-W6-0025****Week Ending Friday May 14, 2004**

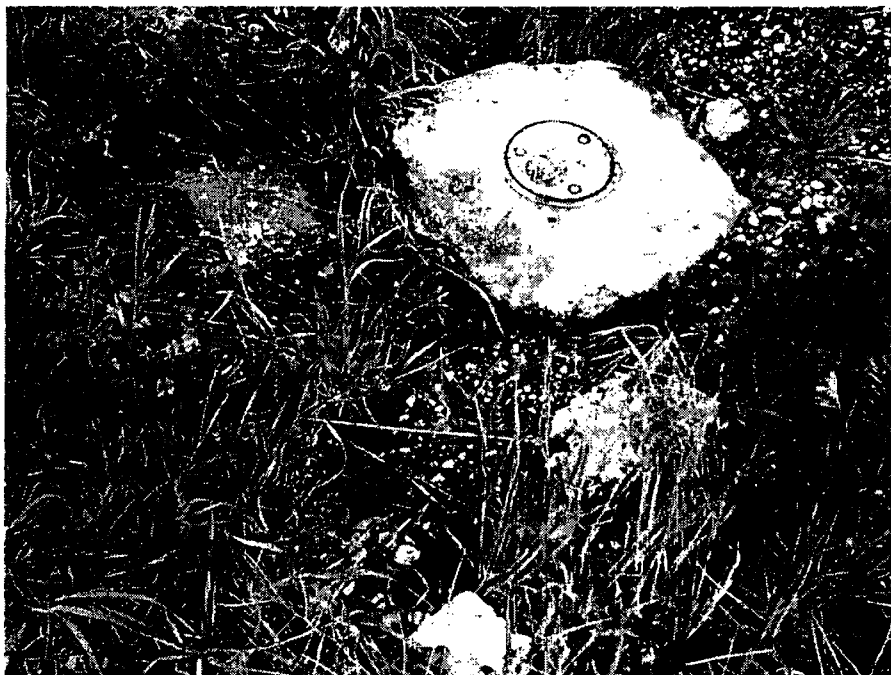
Twenty-seven existing monitoring wells, located across Area 1, were surveyed for DNAPL and LNAPL during the week. Of these wells, measurements could not be collected at well EEG-109 due to well damage. Additionally, measurements at well ST-N-S are likely unreliable due to well damage.

Damaged well ST-N-S: well completion was completely disconnected from well, soils have likely washed from surface into well causing it to be plugged at approximately 11 below ground surface (May 14, 2004).
